Manhole Inspection Summary

Manhole # S250O1011MH

Insp Date: **11/7/06 1:03 PM**

Location Address: **4700 ROLAND AVE**

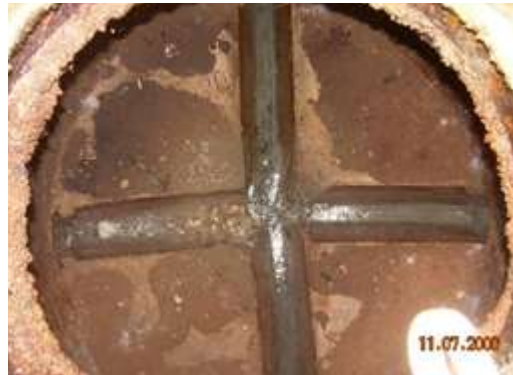
Top View

Bench debris.

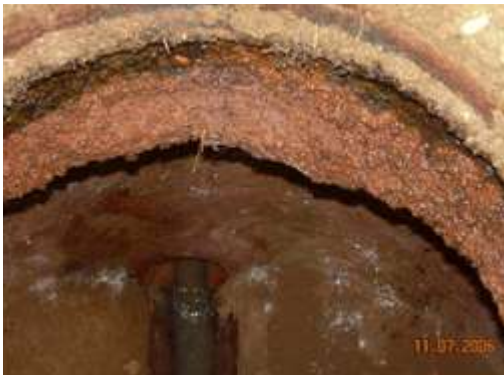
Defect

Frame leaks. Adjustment root intrusion and infiltration.

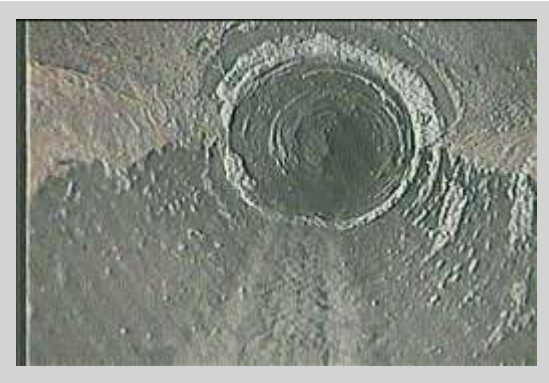
6 in. Circular Gravity Sewer Pipe Out @ 12 O'Clock

Deposits: ☐ None ☐ Mud ☐ Sludge ☐ Debris ☒ Grease

Silt Depth: **0** (in.) Deposits Extent: **Light**

Infiltration: **Evidence**

Pipe Seal Cond: **Roots**

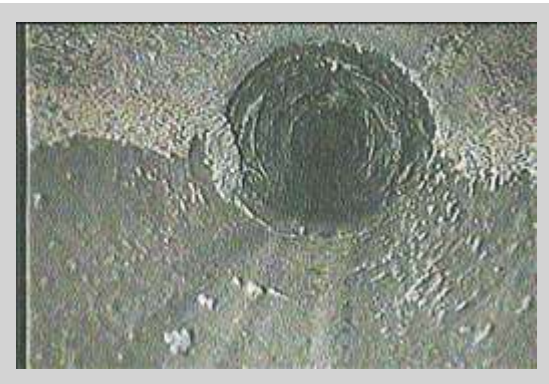
6 in. Circular Gravity Sewer Pipe In @ 3 O'Clock

Infiltration: **Evidence**

Pipe Seal Cond: **Roots**

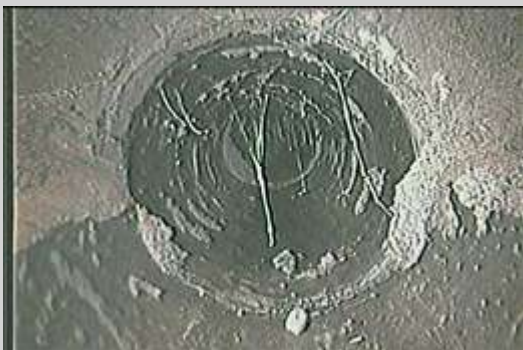
Pipe In @ 9 O'Clock

Deposits: ☐ None ☐ Mud ☐ Sludge ☒ Debris ☒ Grease

Silt Depth: **0** (in.) Deposits Extent: **Light**

Infiltration: **Evidence**

Pipe Seal Cond: **Roots**
